PC-12/47E, YAW DAMPER TRIM ACTIVITY

PC-12/47E MSN 1020 crashed on the 29th September 2008 near Santa Fe, New Mexico, USA. The rudder trim tab was found deflected fully to the right, meaning full left rudder trim [1].

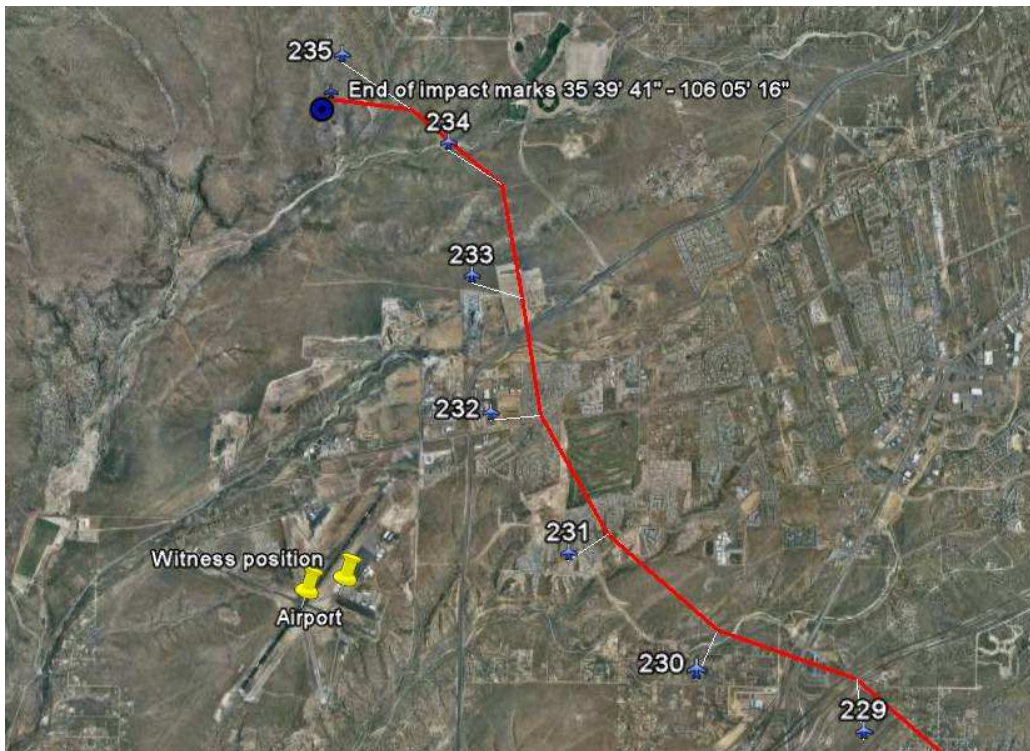
Figure 1 MSN 1020 flight path

During flight test 12-545-F-305 flown on the 15th January 2009, a left hand approach to runway 07L of Buochs airfield, LSZC, was flown, simulating the final part of the MSN1020 approach. See Figure 1 below for the MSN 1020 flight path.

The final, quite steep descent (point 234 to 235 in Figure 1) had obviously to be flown over the runway as can be seen in Figure 2 and Figure 3.

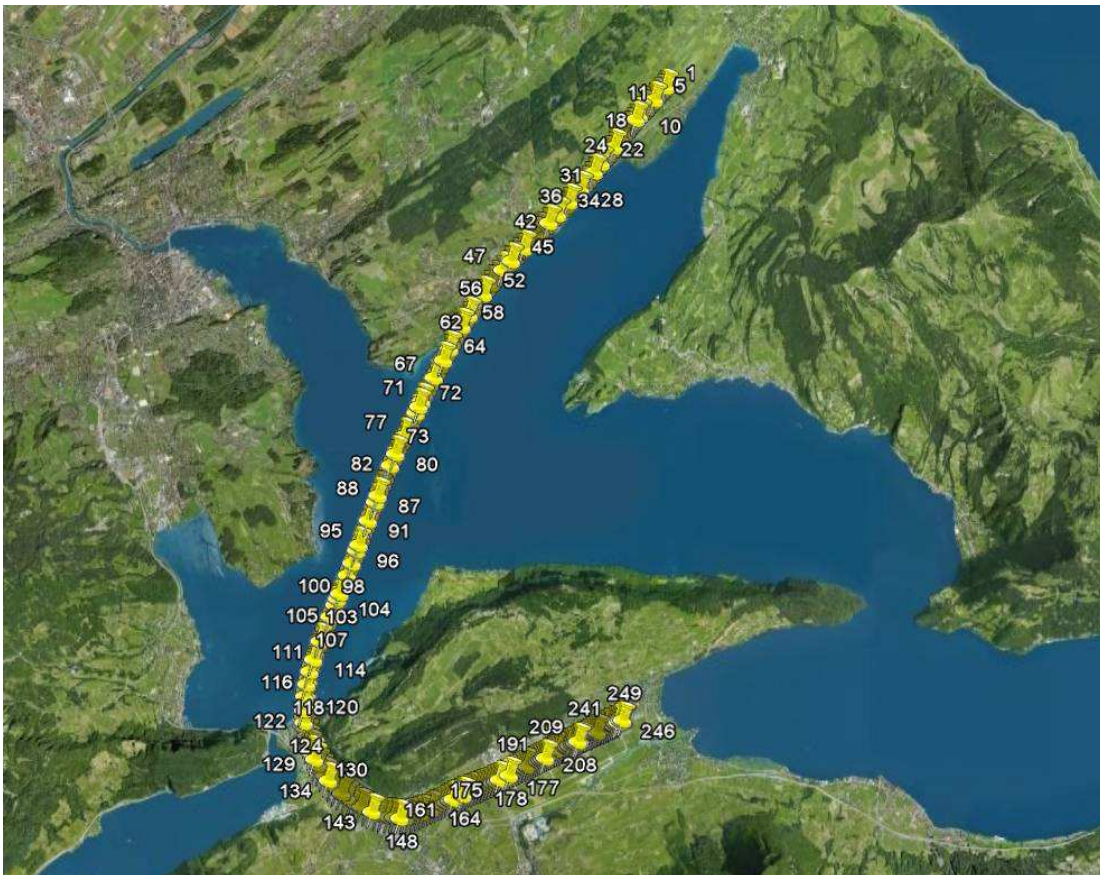
Figure 2 Approach to LSZC RWY 7L

Data between 14:21:03 and 14:25:13 (rows 5800 and 6050 in the excel sheet) covers the approach as shown in Figure 2.

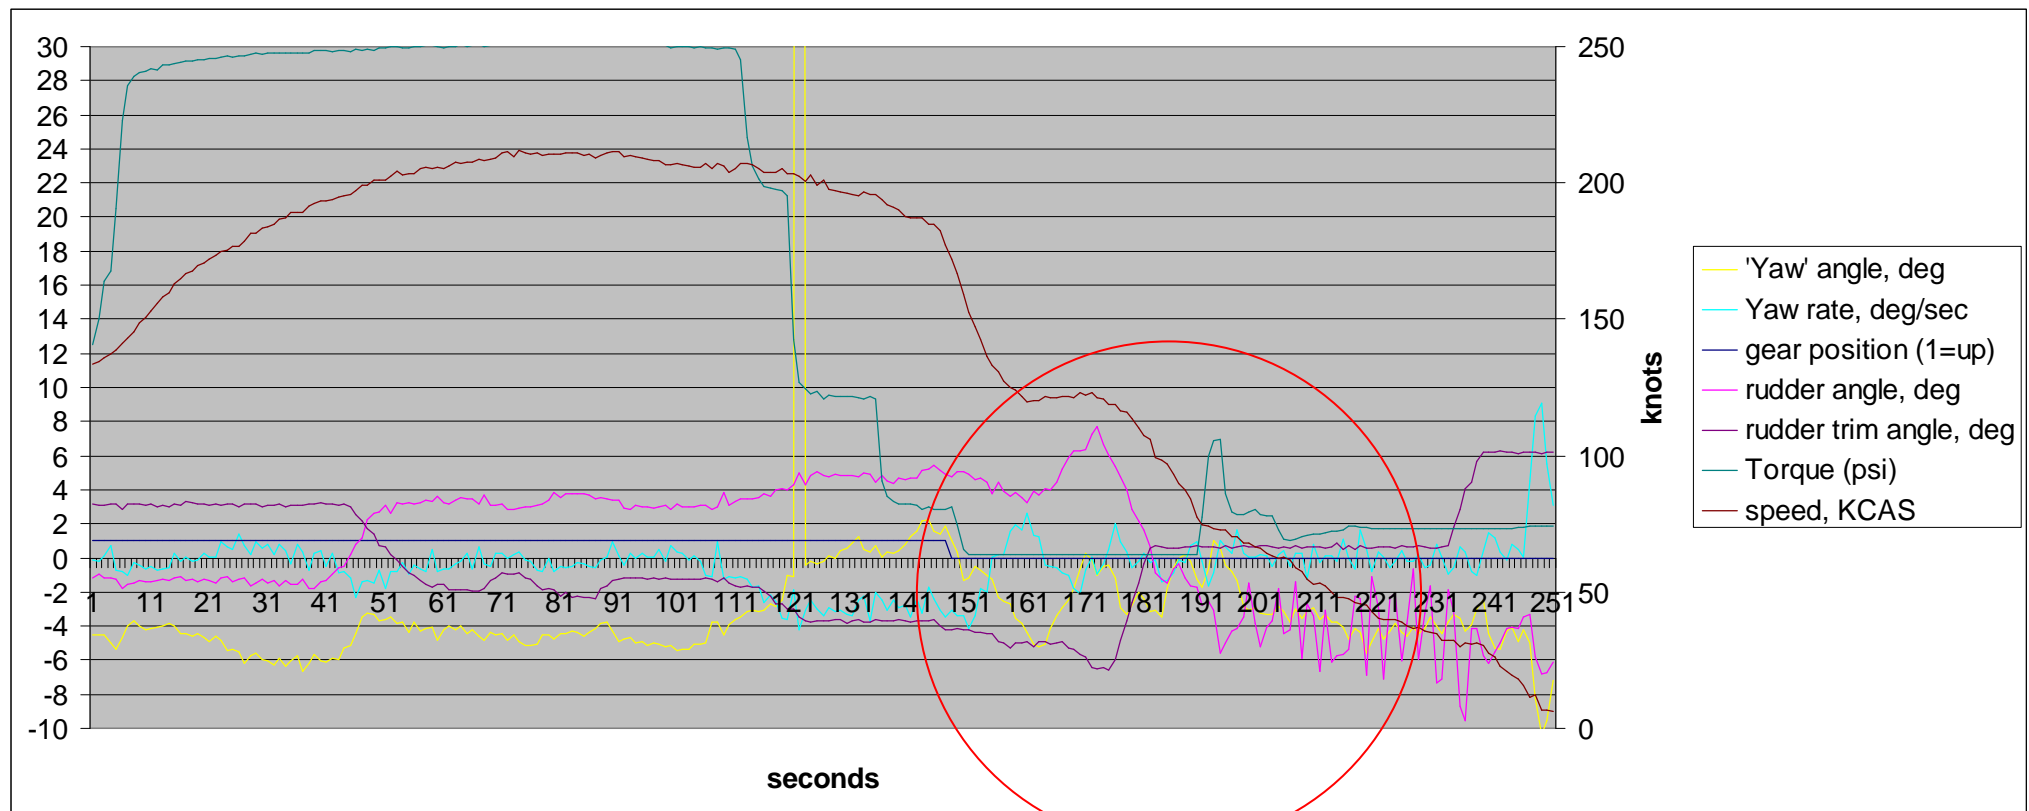
For the time frame covered in Figure 2 and Figure 3, the following parameters are shown in Figure 4 below:

In the above chart, it can be seen that from an initial slight right trim ($\sim 3^\circ$) with associated minor right rudder deflection ($\leq 2^\circ$), the trim setting changed gradually to full left around data point 175. At this point (shortly before touchdown, refer to Figure 3) the rudder trim angle had reached -6.5° , which is full left trim. The rudder deflection was around 4° left for most of the approach and peaked shortly at 8° . Figure 5 below shows the 50 sec before touch-down. At 175 sec, the parameters were as follows:

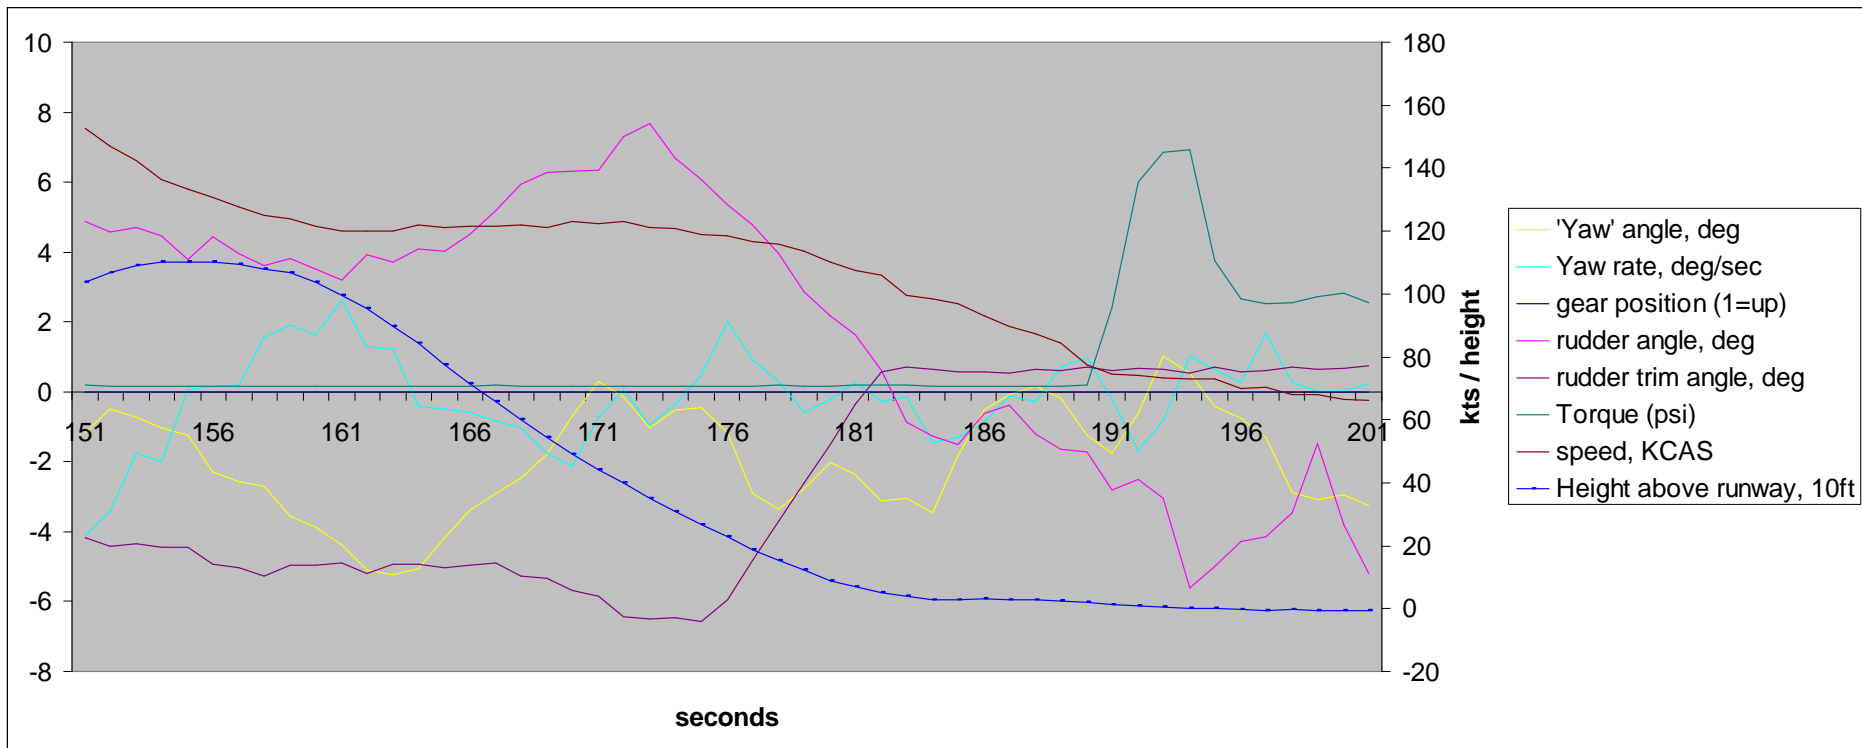
Figure 5, 50 seconds before touchdown

Power: idle
Flaps: Approx 10° (refer to EXCEL file)
Speed: ~ 120 knots
Rudder trim: full left
